Contractual lessons from construction failures: part one

Dr Donald E Charrett
Barrister, Melbourne

Quebec Bridge, Canada (1907)

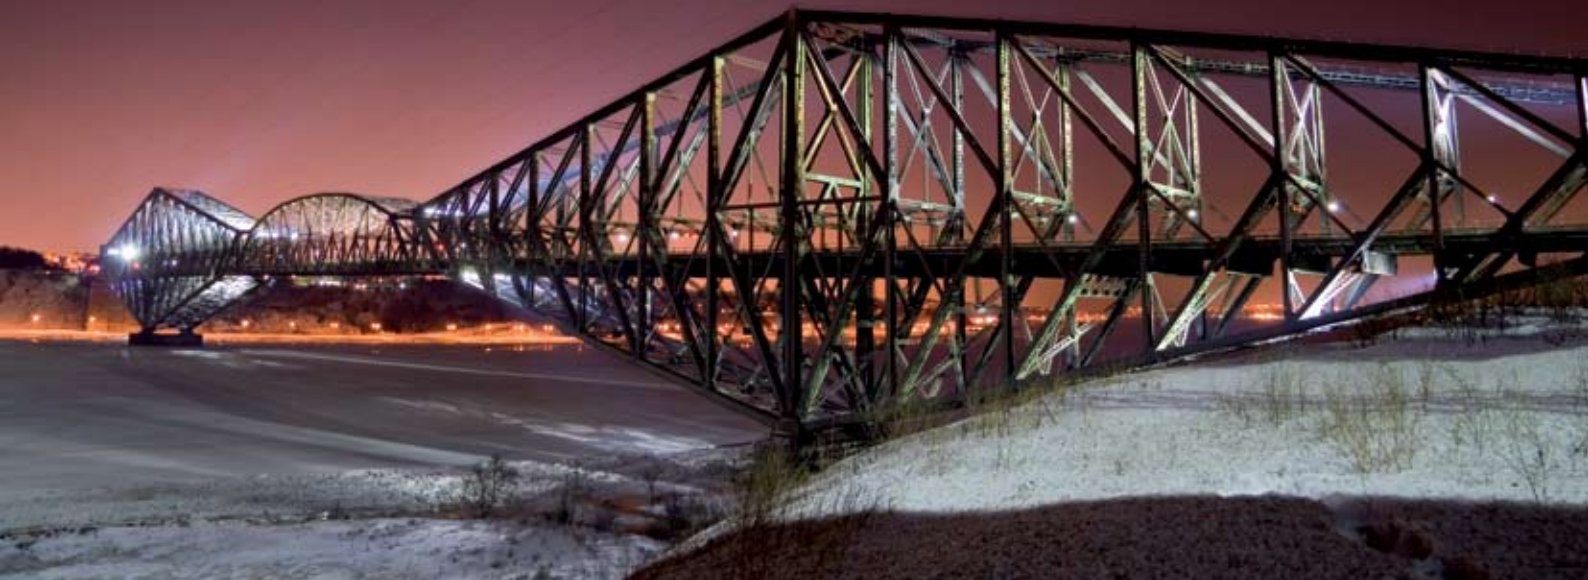
Above: Quebec Bridge, Canada
