WEST GATE BRIDGE, MELBOURNE (1970)

WEST GATE BRIDGE

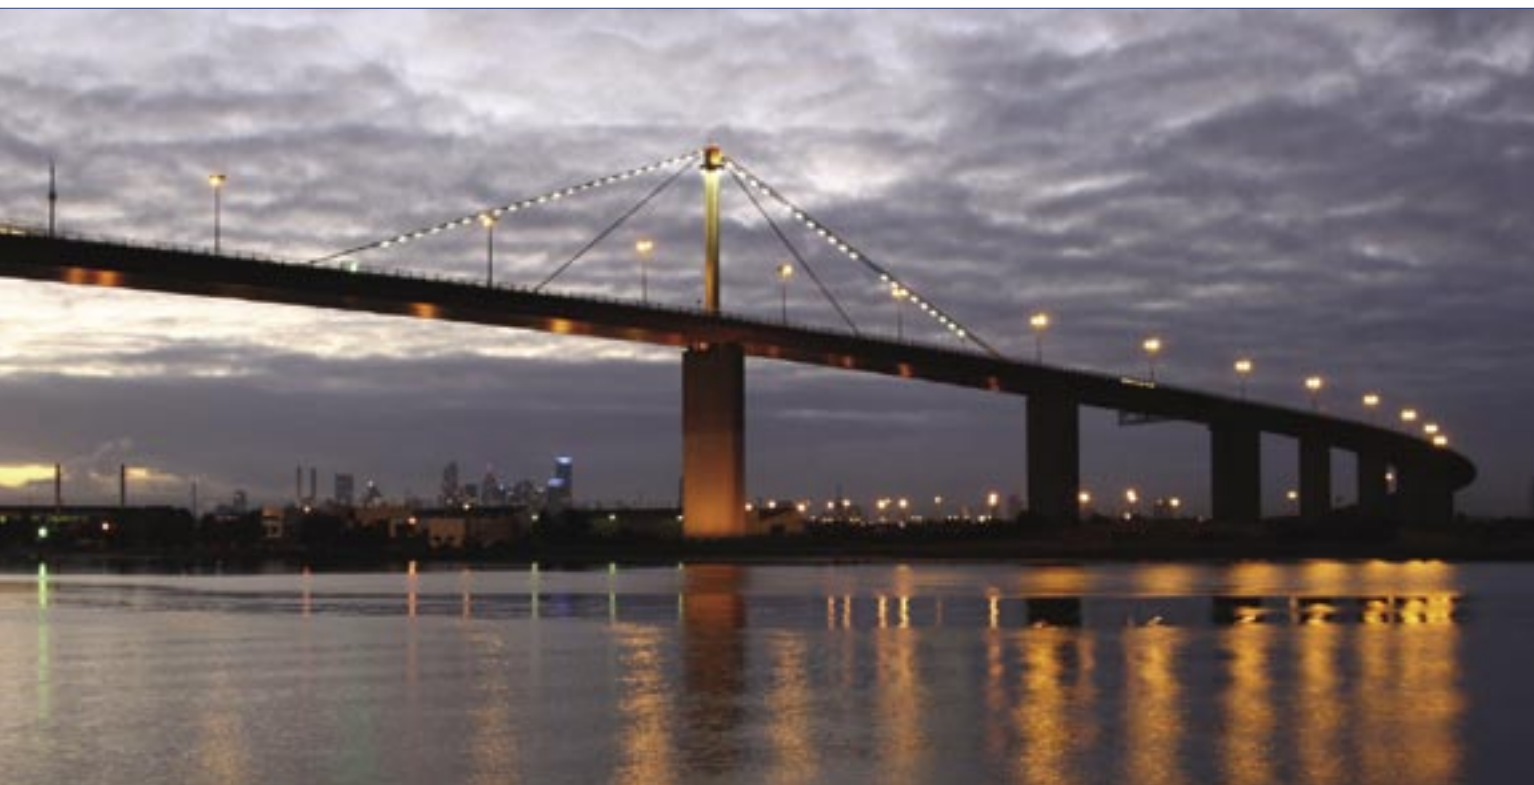
On 15 October 1970, the 112 m span on the western side of the Yarra known as span 10-11 collapsed suddenly during construction, resulting in the death of 35 people. The Coroner immediately constituted a five-man expert technical committee to observe and record facts on site. The evidence collected by that committee was invaluable to the Coroner and the Royal Commission, which was announced the day after the collapse. Letters Patent dated 21 October 1970 appointed Justice Barber of the Supreme Court, an Australian Professor of civil engineering and a distinguished English bridge engineer as Commissioners. A preliminary hearing was held on 20 October 1970, followed by 80 sitting days between 5 November 1970 and 15 June 1971. It heard evidence from 52 witnesses and considered 319 exhibits. The Royal Commission was charged with enquiring into and reporting on the circumstances surrounding and the cause or causes direct and indirect of the failure of steel span 10-11, and whether any aspect of the design of the steel span was inadequate or undesirable³. The Report dated 14 July 1971 is the source of the following observations.
